Drive Warning Concept

Software Change Notification

Document SWSCN001_DriveWarningConcept_EP
Version 002₅₃
Source D:\SVNRoot\Doc\Software\SWSCN\
Destination T:\Doc\Software
Owner AB

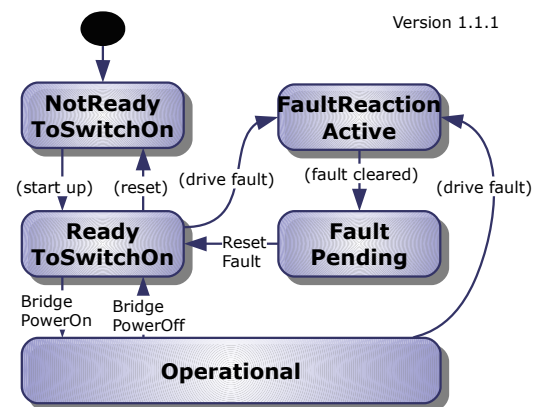
Bild 1: Drive statemachine with FW<1037

There is no global warning concept. The state 'ReadyToSwitchOn' just indicates that the drive has finished initialization. A potential problem like a missing bridge voltage or an open *SafeTorqueOff* input may be tested using dedicated registers but is not signaled as a state until the user tries to enable.

PowerBridgeVoltage limits are monitored in state 'Operational' only. Missing power or over-voltage in the state 'Operational' leads to switch off the drive with the error message 'BridgeVoltageOutOfRange' and the transition to the state 'FaultPending'. The error must be acknowledged using 'ResetFault', which results in a transition to the state 'ReadyToSwitchOn'. Only after an enable with faulty power, the error message 'BridgeVoltageOutOfRange' comes again.

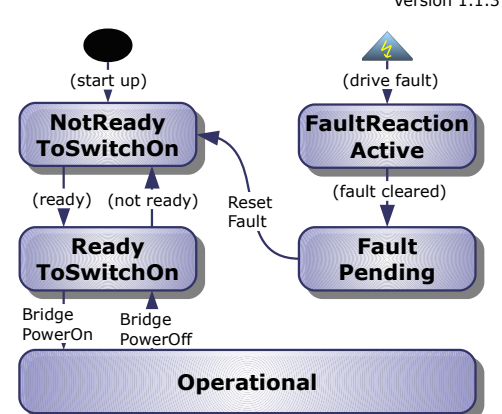
Bild 2: Drive statemachine with FW>=1037

PowerBridgeVoltage limits are monitored also in the state 'ReadyToSwitchOn'. The term "BridgeVoltageOutOfRange" is now either an **error** message (in state 'FaultReactionActive' or 'FaultPending') or a **warning** message (in state 'NotReadyToSwitchOn').

Missing power or over-voltage in the state 'ReadyToSwitchOn' leads to the **warning** 'BridgeVoltageOutOfRange' and the transition to the state 'NotReadyToSwitchOn'. Such a warning may not be reset. The drive can not be activated until the power is applied correctly. If the power is correctly applied, the warning disappears automatically and the drive changes to state 'ReadyToSwitchOn'. The drive can then be switched on.

Missing power or over-voltage in the state 'Operational' leads to switch off the drive with the **error** message 'BridgeVoltageOutOfRange' and the transition to

the state '*FaultPending*'. The error must be acknowledged using '*ResetFault*', resulting in a transition to the state '*NotReadyToSwitchOn*'. If power is correctly applied to the drive, it changes automatically to the state '*ReadyToSwitchOn*' in the next cycle and can then be switched on. If the power is still not ok, the drive remains in the state '*NotReadyToSwitchOn*' and in the next cycle, the **warning** '*BridgeVoltage-OutOfRange*' pops up.
